Technical Report Report No: R19568 – Rev 1

Brick Slip Rainscreen System

CWCT Test Sequence

Project Ref: 19568

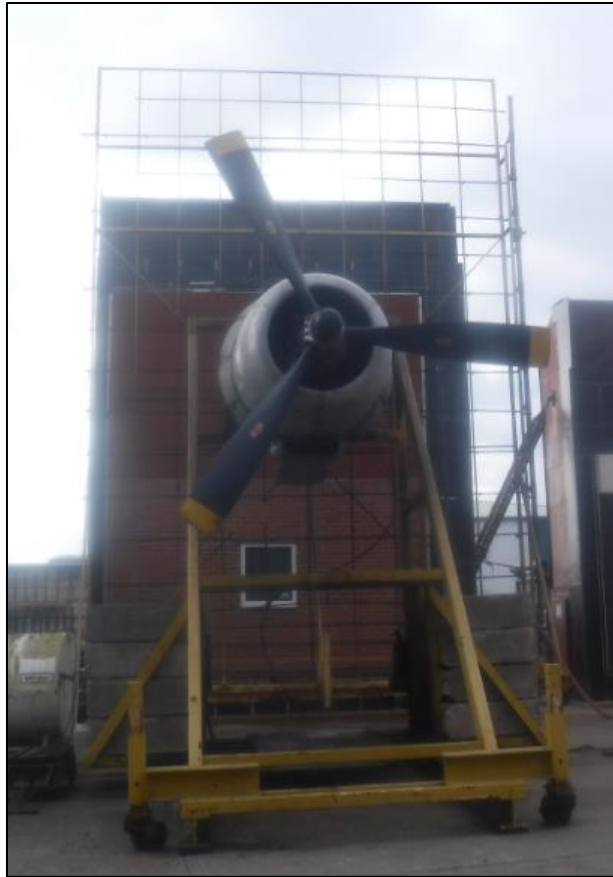
Photograph No. 1

Test Sample During Testing

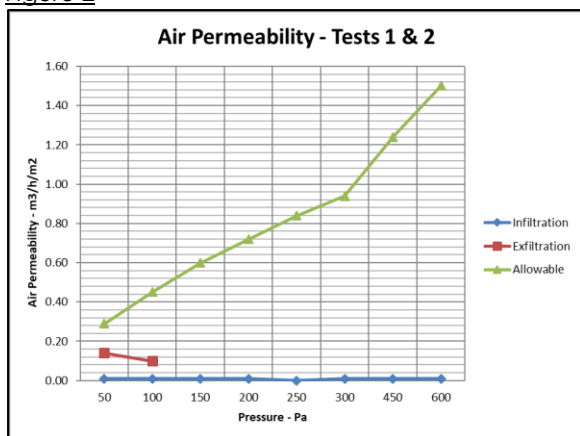
Figure 2

Pressure Differential Pa	Maximum Air Permeability Rate – Infiltration m ³ /hr/m ²				Maximum Air Permeability Rate – Exfiltration m ³ /hr/m ²			
	Test No. 1		Test No. 5		Test No. 2		Test No. 6	
	Ambient °C	12.3	Ambient °C	11.2	Ambient °C	12.3	Ambient °C	11.2
50	0.01		0.00		0.06		0.00	
100	0.01		0.00		0.06		0.03	
150	0.01		0.00					
200	0.01		0.00					
250	0.00		0.00					
300	0.01		0.00					
450	0.01		0.01					
600	0.01		0.01

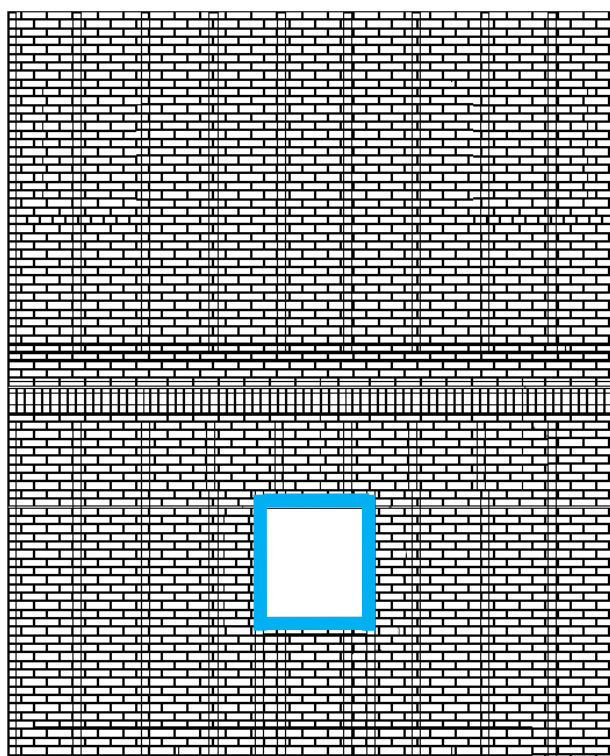
Figure 4

The sample was subjected to hose testing, as described in section 5.3.2. During the test, and for 30 minutes following the cessation of spraying, the sample was monitored for water ingress and none was found.

Hose Test Areas

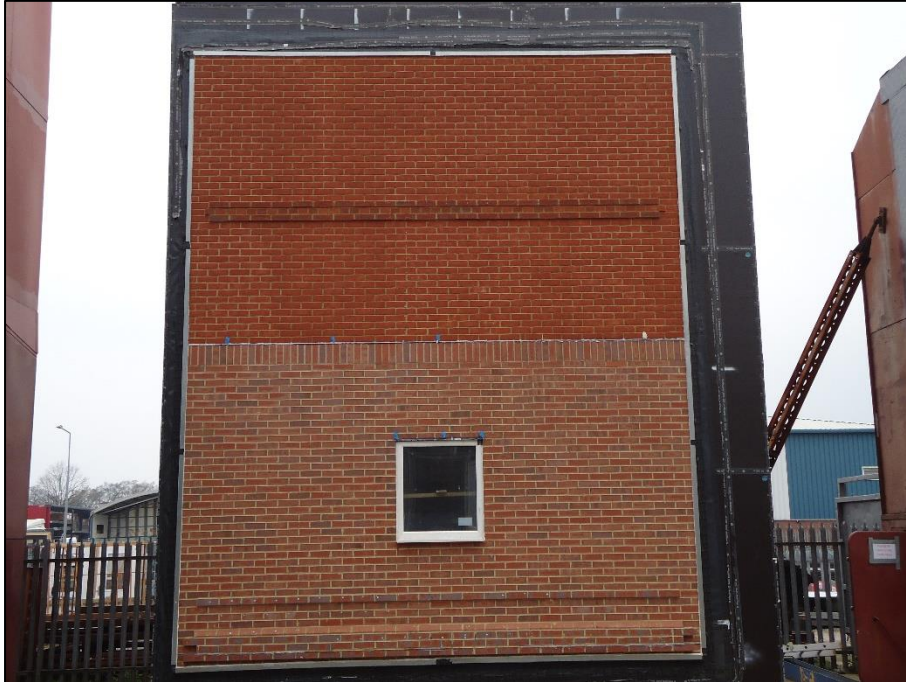
Photograph No. 3

Sample prior to the dismantle.

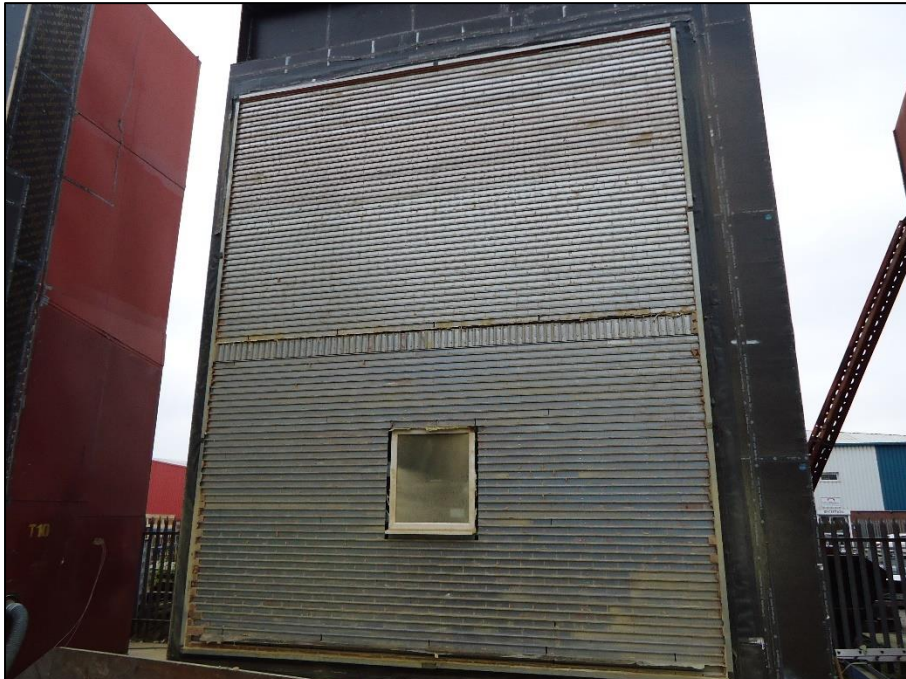
Photograph No. 4

'Sure Brick' Rail layout with brick slip removed.

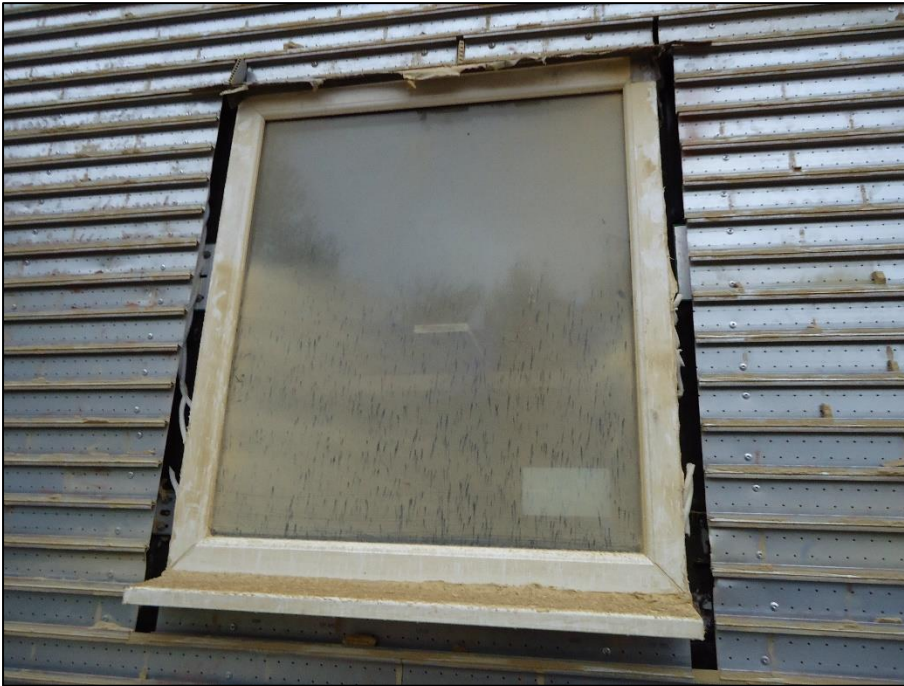
Photograph No. 5

Window interface
with brick slip
removed.

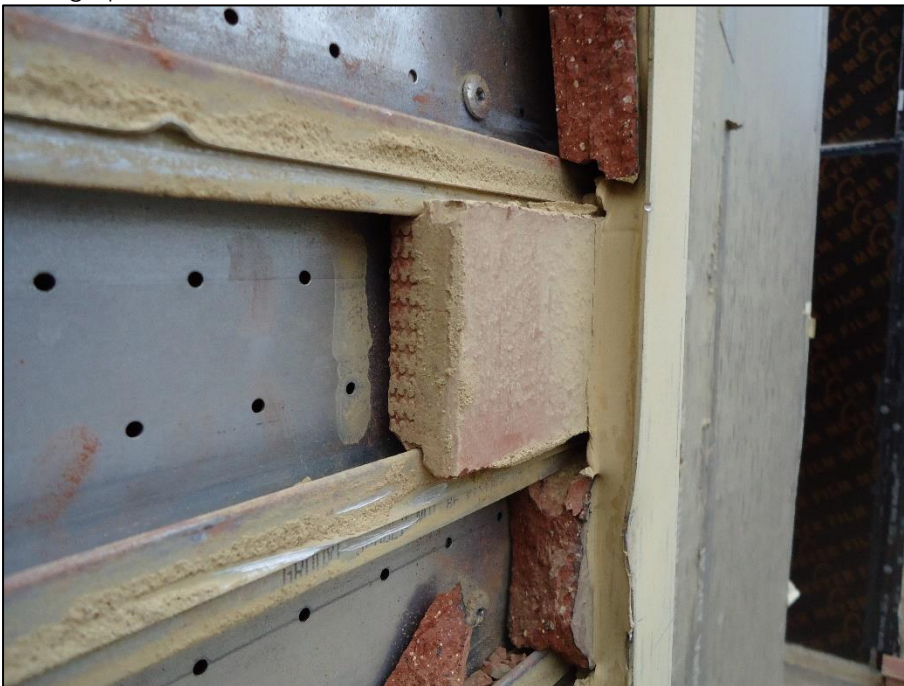
Photograph No. 6

Brick slip (stretcher slip
profile) between
support rail.

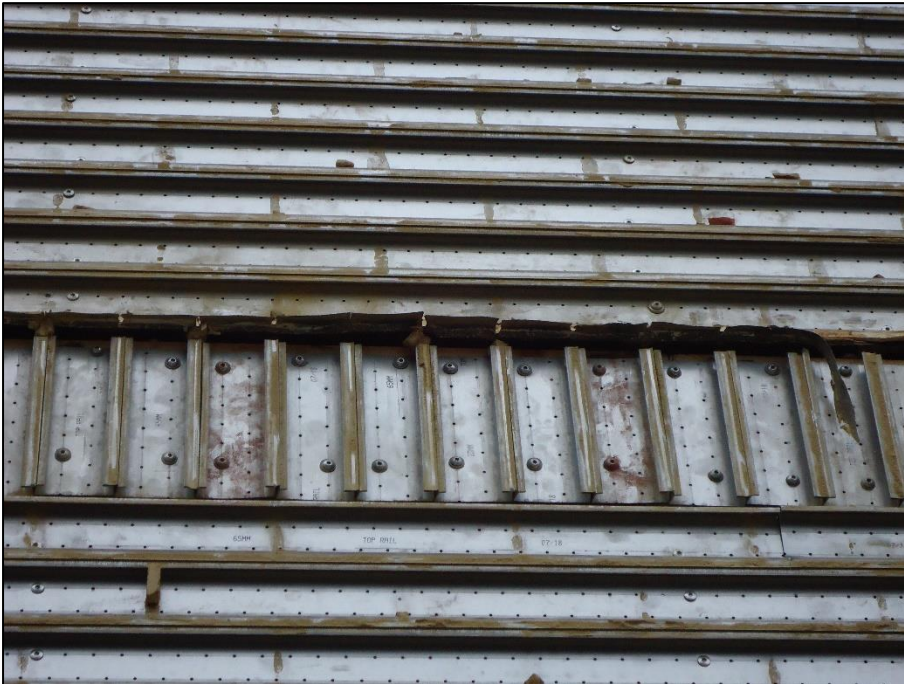
Photograph No. 7

Soldier support rail layout

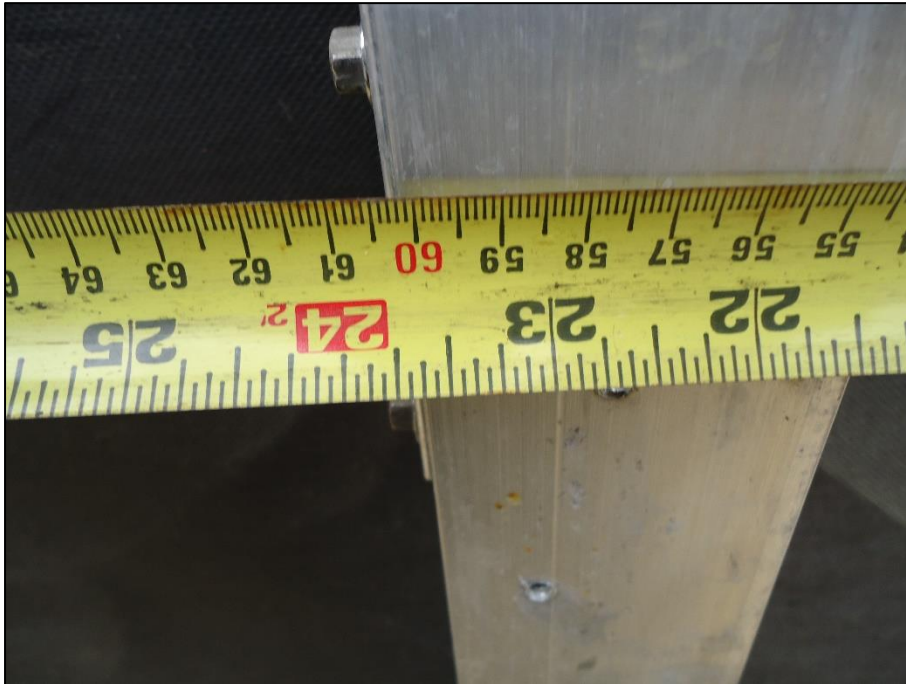
Photograph No. 9

Mid vertical rail span measured (600 mm).

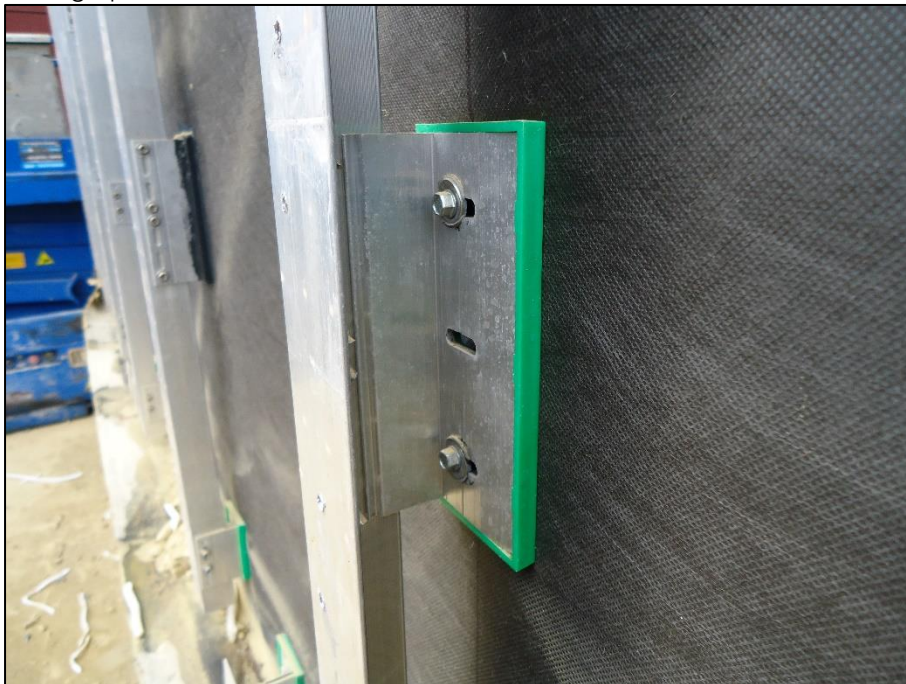
Photograph No. 10

Helping hand bracket connection to vertical rail.

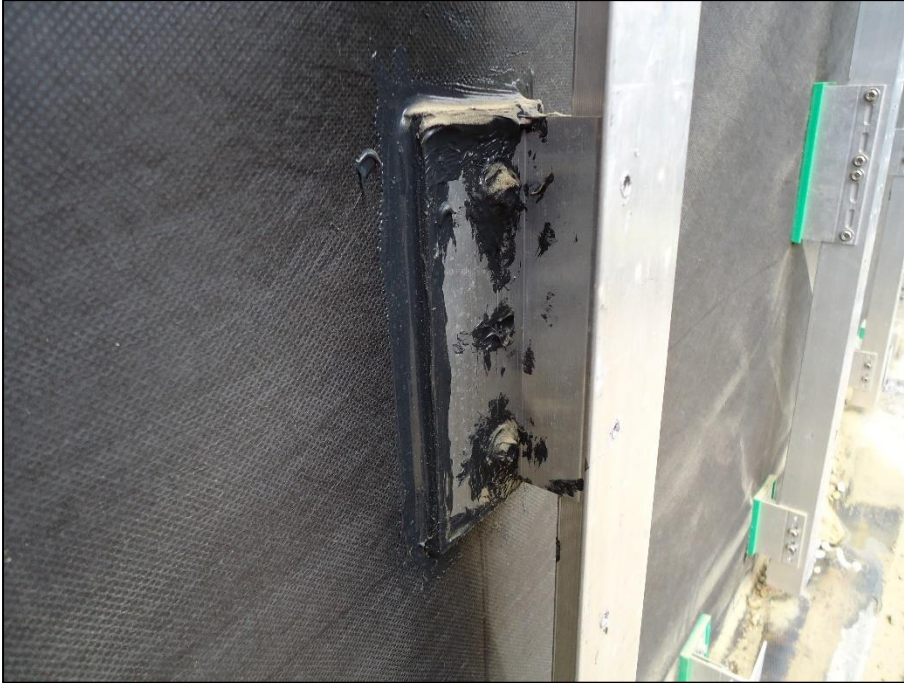
Photograph No. 11

Helping hand bracket
and fixings sealed.

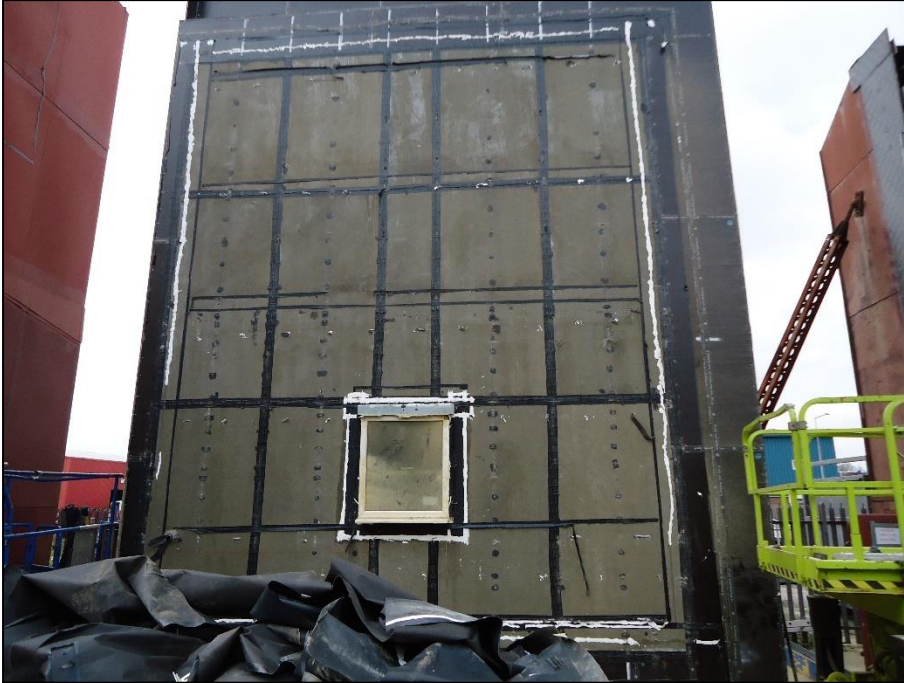
Photograph No. 13

Cement boards.

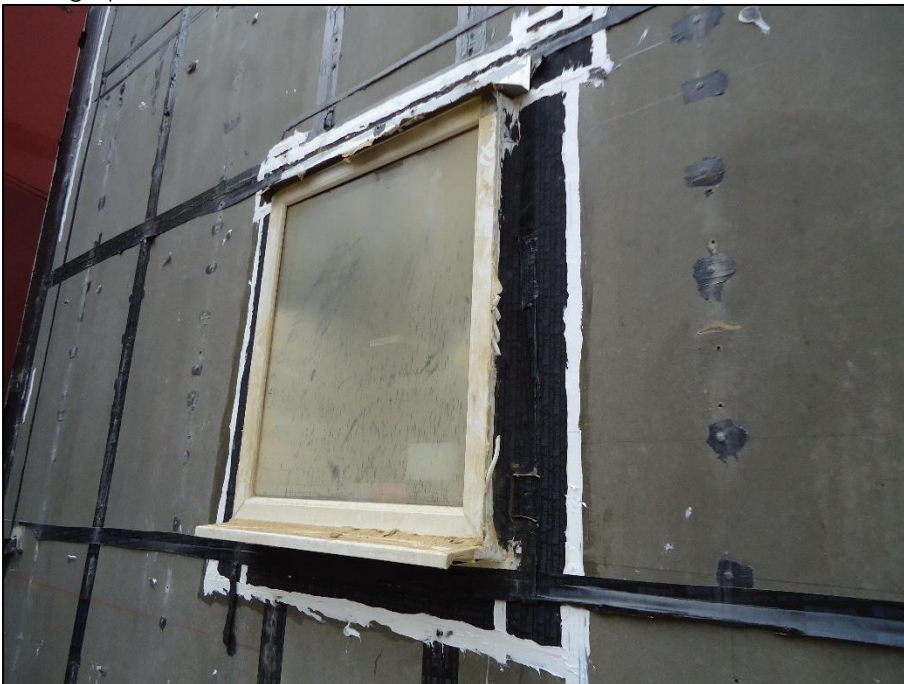
Photograph No. 14

Window interface to cement board.

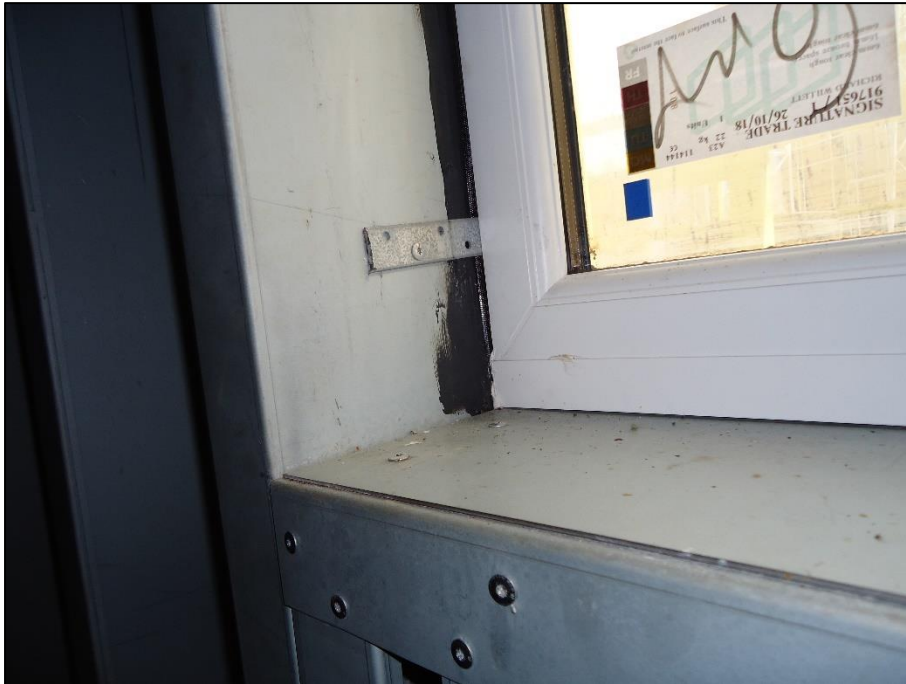
Photograph No. 15

Internal – Window fixing bracket to SFS.
